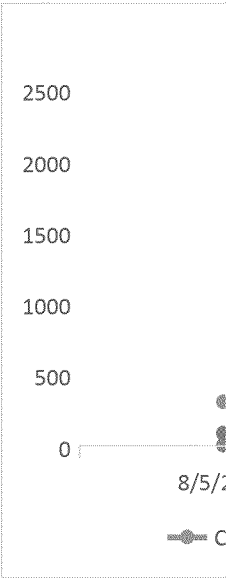
ocation ID	De Sampled	Cadmium	Copper	Lead	Manganes	Zinc
Bakers Bri	8/5/2015	0.353	2.28		306	85.8
Bakers Bri	8/6/2015	0.336	1.88		296	110
Bakers Bri	8/6/2015	5.32	189	1.56	2090	1700
